Fountain Creek Watershed 101 and Water Quality

Fountain Creek Watershed Project Manager

Colorado Springs Utilities

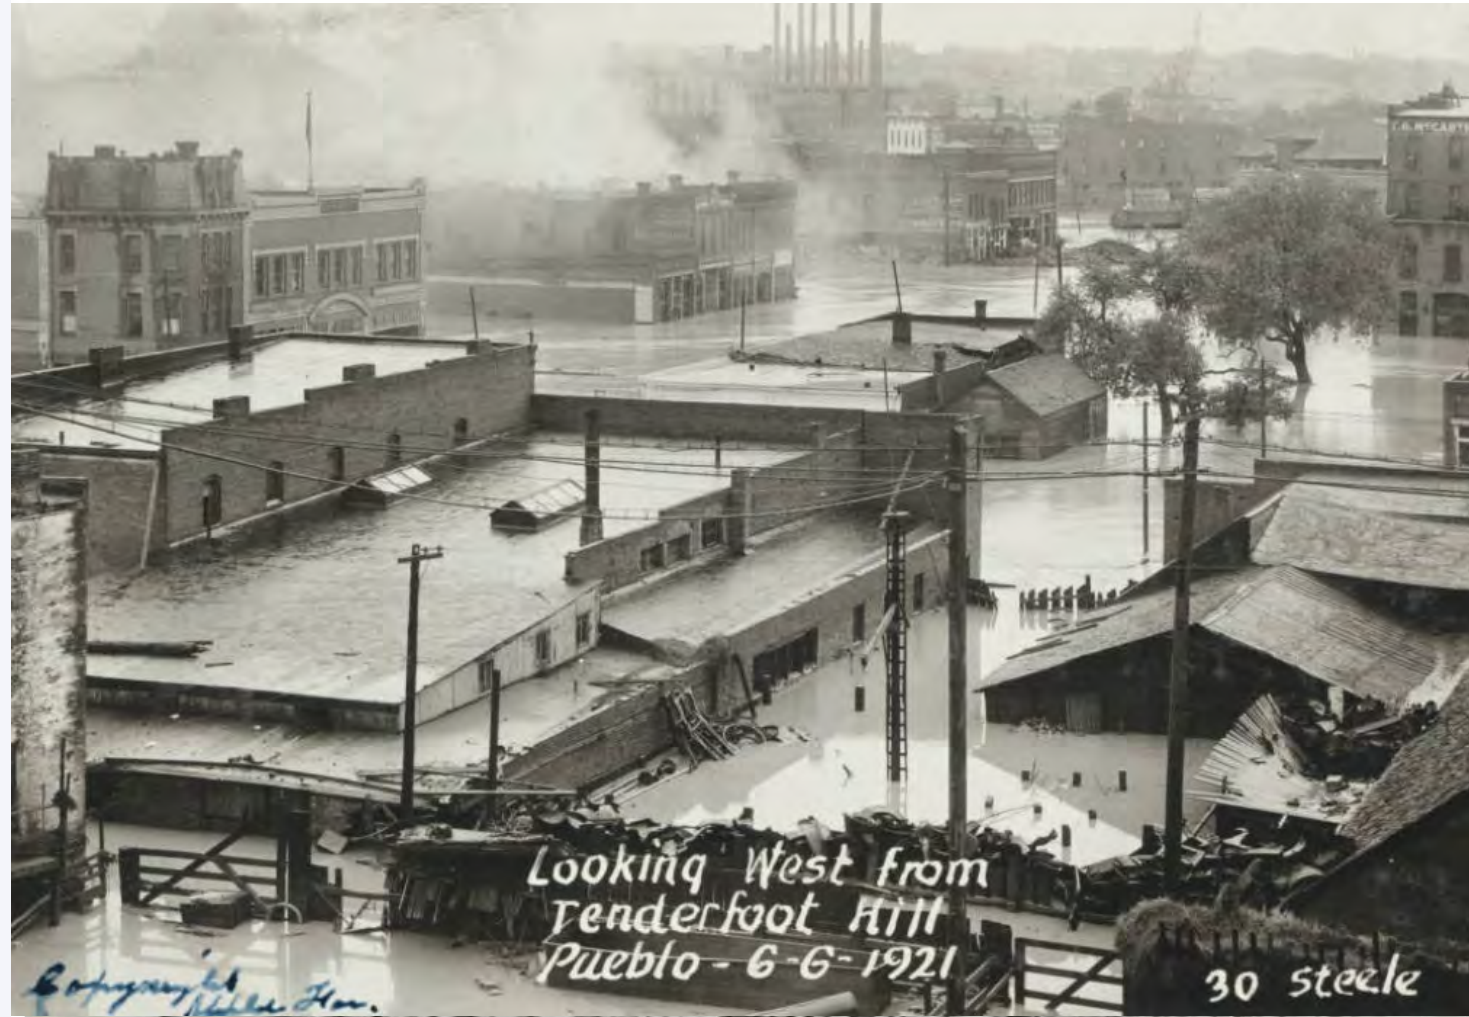
1921 Pueblo flood. Photo credit: University of Southern Colorado <https://scalar.usc.edu/works/1921-the-great-flood/home>

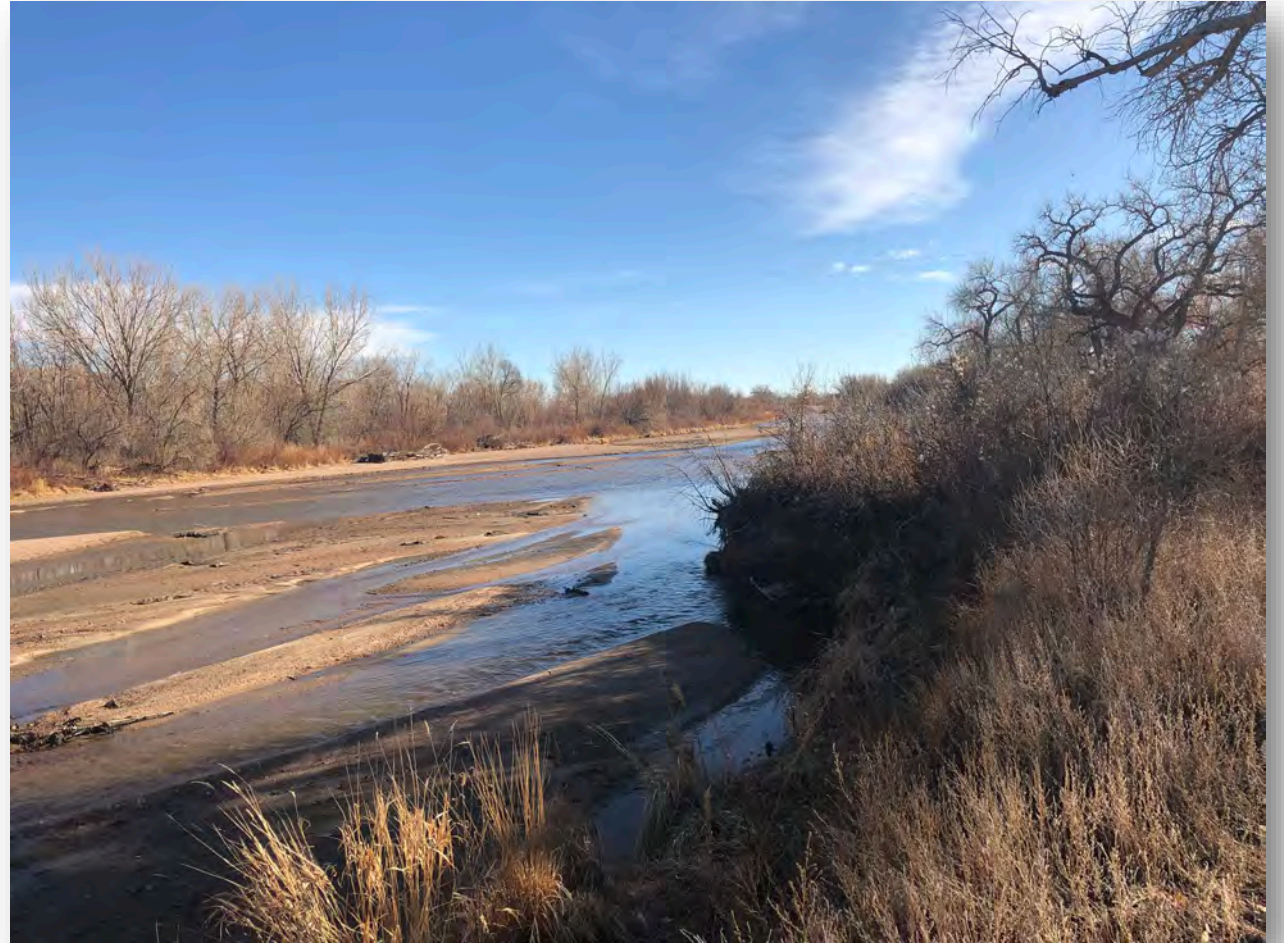
- The interactions between the physical shapes of river and the water and sediment transport process
- Geomorphology at 10 sites
- Annual with change detection maps to measure erosion and deposition

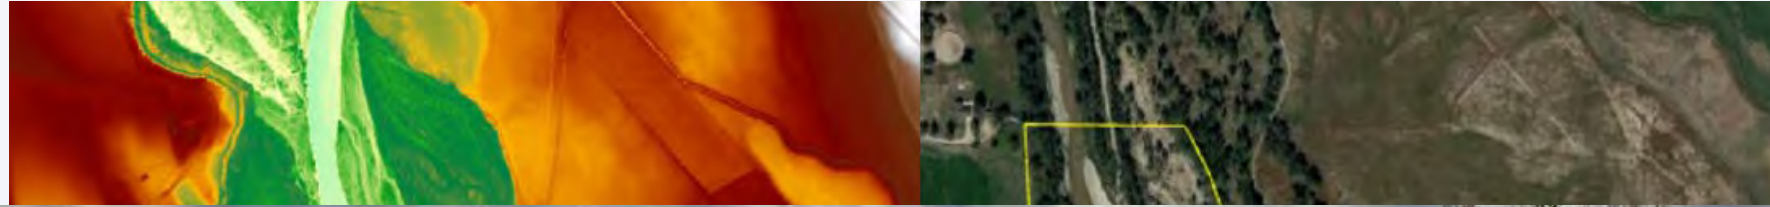
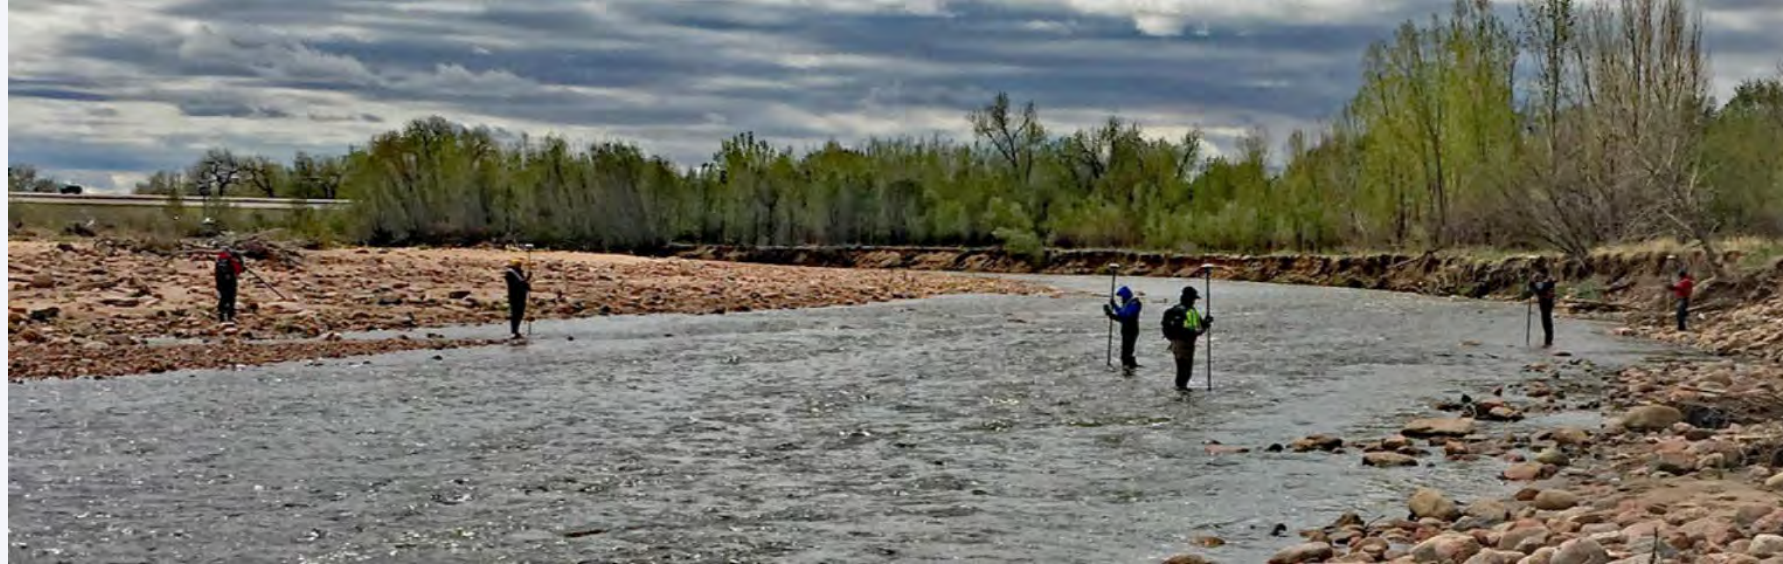
- RTK-GNSS: real time kinematic positioning surveying to correct for satellite navigation system
- LiDAR: Light Detection and Ranging

El Paso County LiDAR (De-trended)

Google Earth Imagery

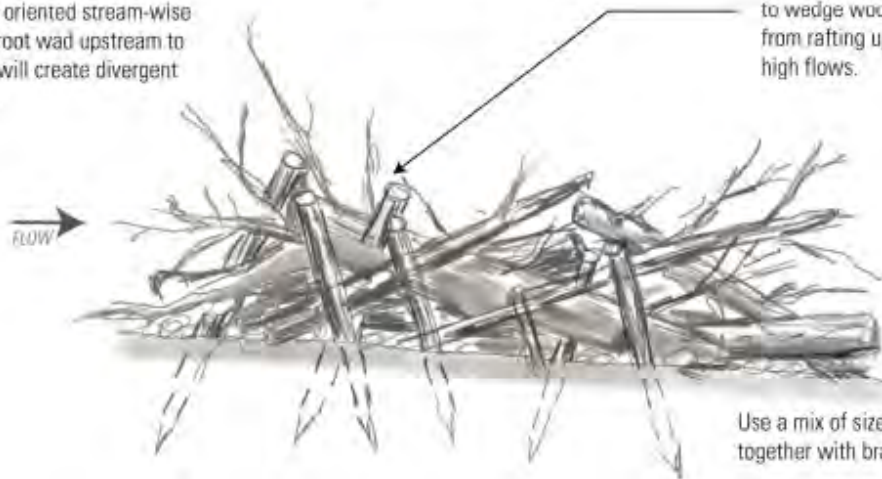
PROFILE VIEW

Start with key pieces oriented stream-wise and face butt end or root wad upstream to maximize width that will create divergent flow paths around it.

Drive posts in to bed angled inwards to wedge wood pieces and prevent them from rafting up and floating away in high flows.

Use a mix of sizes of wood and tangle together with branches.

- Structures – not exceed ordinary high-water mark, very porous
- Goals – water quality, fuels break, resiliency
- House Bill 270
